2019 Periodic Inspection Report

*Reflection Lake South and North Dams
Spokane County, Washington*

November 2019

DSO File SP55-0050, 0362

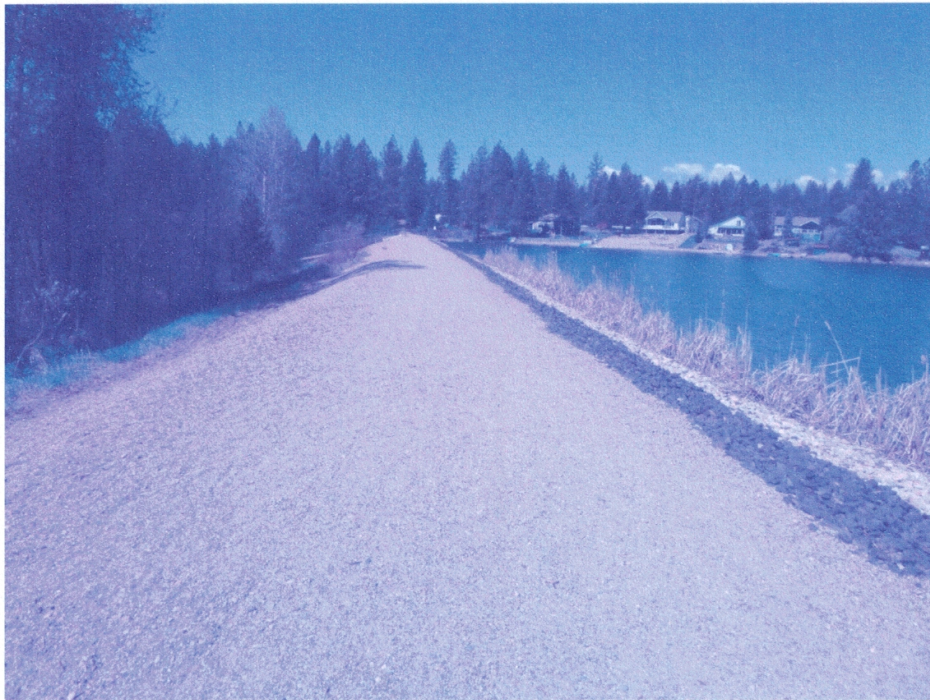
Photo 2: Reflection Lake South Dam - crest

The dam crest was also in a good condition, no cracks, sinkholes, settlement, erosion, or other signs of instability (Photo 2).

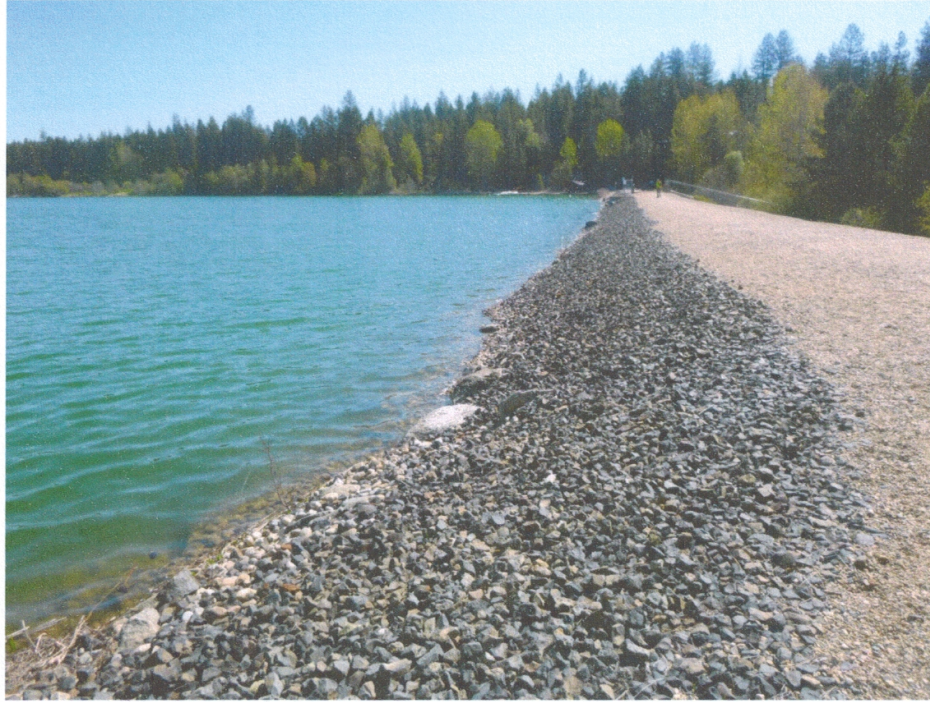
Photo 3: Reflection Lake South Dam - upstream face

2019 Inspection. An examination of the visible sections of the upstream slope revealed that it was in generally good condition. There were no slides, slumps, erosion, or other unusual conditions noted. No obvious deficiencies were observed on the visible elements of the upstream face of the dam. The upstream slope is protected by a layer of cobbles, which appears to be performing adequately in limiting wave erosion (Photo 3).

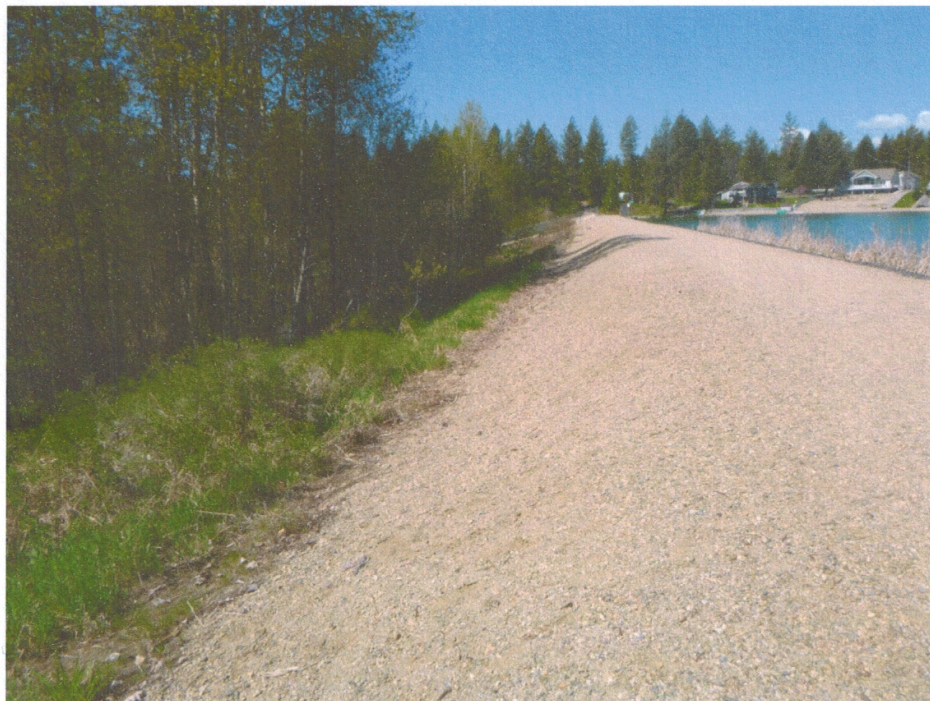
Photo 4: Reflection Lake South Dam - downstream face

An examination of the downstream face of the South Dam revealed that it was clear of vegetation to about 15 feet down the slope (Photo 4): After that, there were areas covered with vegetation of varying height, which made inspection of the embankment surface more difficult. We observed no obvious signs of instability, such as cracking, slumps, slides, depressions or sinkholes. However, the downstream slope face needs to be armored since it is a loose condition. We recommended to armor the slope face during the inspection before any erosion or depressions occur.

2. Armor slope face of South Dam. The downstream slope face on the South Dam needs to be armored before any erosion or depressions occur.
3. Monitor seepage near left abutment of South Dam. There is a seepage area near the left abutment on the South Dam that produced standing water on the embankment. It is required to monitor this area periodically to determine if there are any significant changes on the amount of water and/or if signs of increased seepage such as bubbles or dirty water flow are present. In the event of any significant changes, the DSO should be notified as soon as

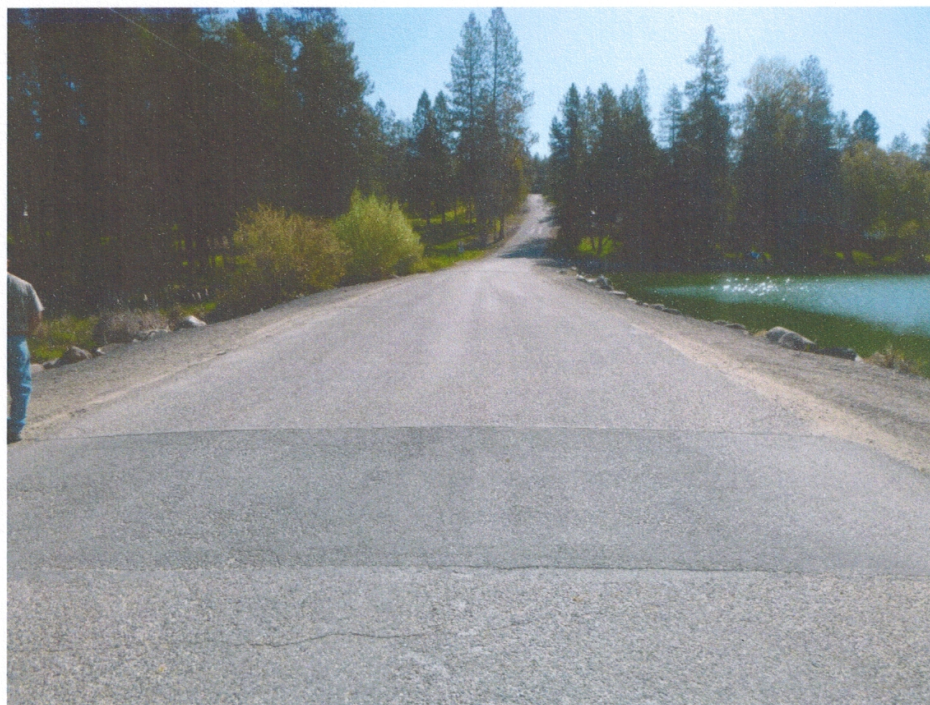
Photo 5: Reflection Lake North Dam - crest

The crest of the North Dam likewise exhibited no signs of instability such as depressions, sinkholes or slumps, and the roadway surface appeared well maintained. The asphalt patch indicating the location of the repaired auxiliary spillway looked well constructed, as did the patch for the removed trick-tube outlet near the west abutment of the dam (Photo 5).

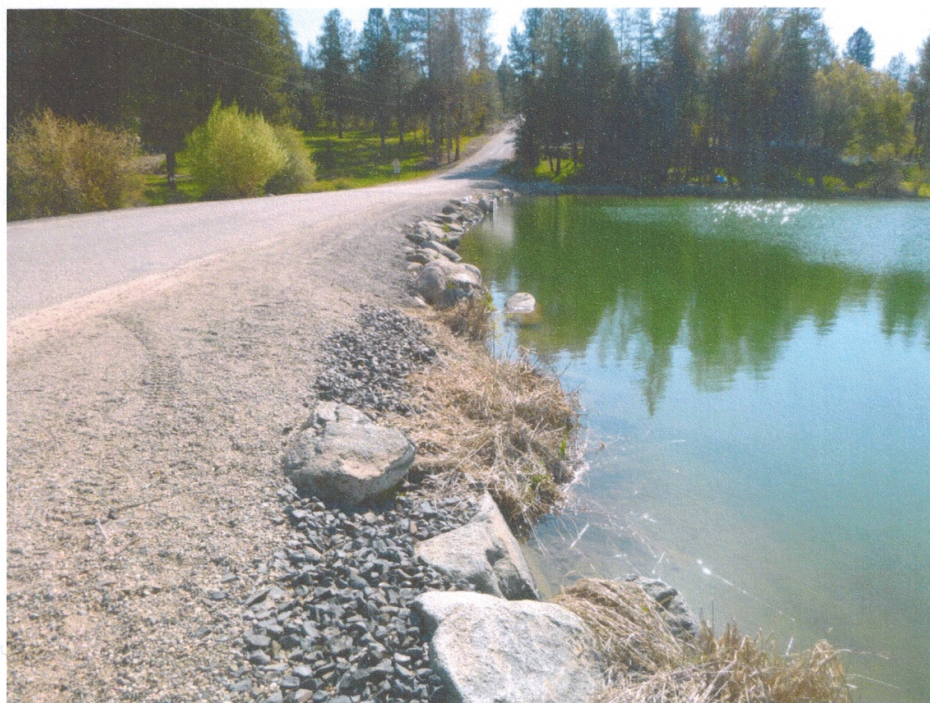
Photo 6: Reflection Lake North Dam - upstream face

2019 Inspection. Our examination of the visible portion of the upstream slope revealed no signs of instability, cracks, slides, depressions or other unusual conditions (Photo 6). The majority of the upstream slope is covered with large boulders and the width of the crest is uneven in length.

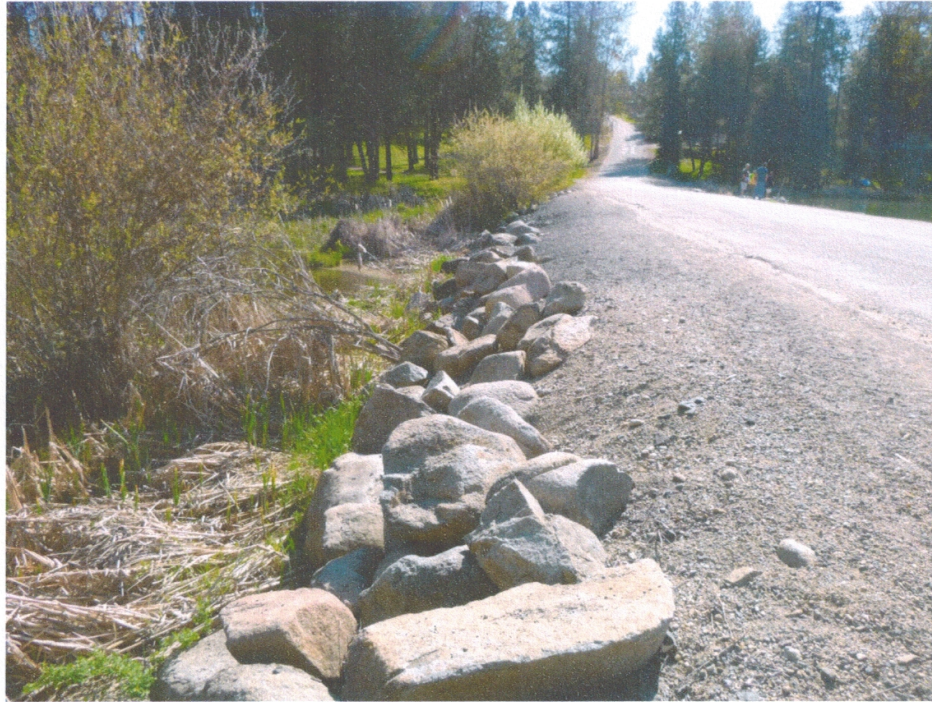
Photo 7: Reflection Lake North Dam - downstream face

Our inspection of the downstream face of the North Dam revealed no signs of cracking, slides or instability (Photo 7). No seepage was noted on the embankment of the North Dam. We found a small area of slumping near the left abutment during the inspection (Photo 16). It is required to patch this area with fill materials and monitor periodically. In general, the DSO should be notified if any signs of slumps or depression in the embankment become evident.

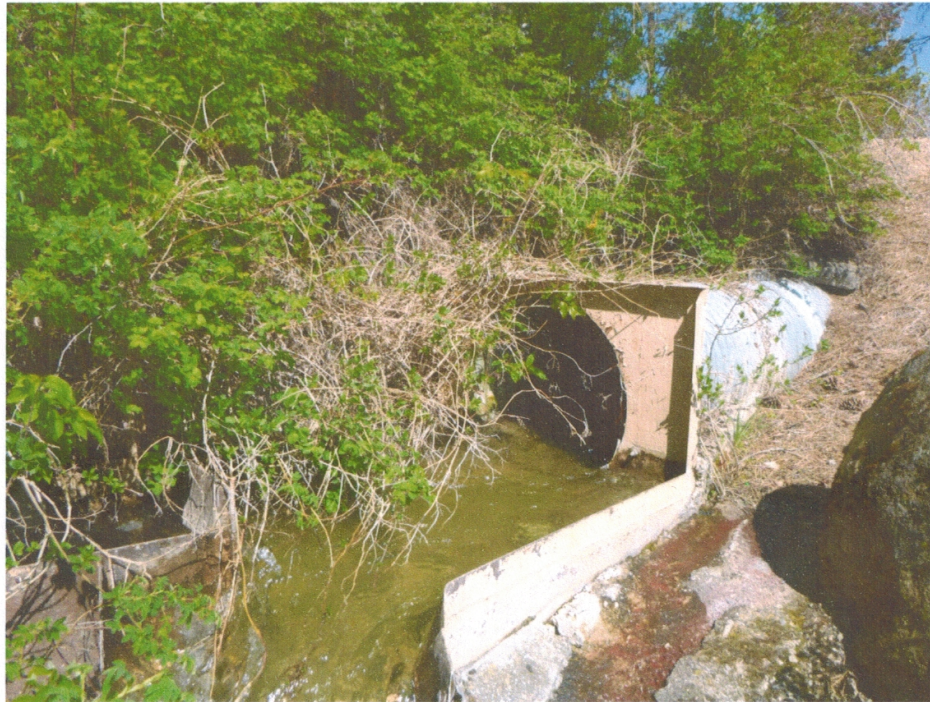
Photo 9: Principal Spillway Discharge on South Dam

2019 Inspection. At the time of the inspection, water was flowing in the outlet, approximately 1/3 full (see Photo 9). A visual inspection of the downstream chute revealed that the chute and concrete support were in good condition, with no visible damage or instability. The sliding plate at the spillway entrance appeared to be completely lowered, although water was able to pass through. It should be noted that the metal plates would significantly hinder flow through the outlet. In most cases that will not be an important issue, but should be taken into consideration for significant storm events. It is suggested that this plate be kept in an up position as much as possible.

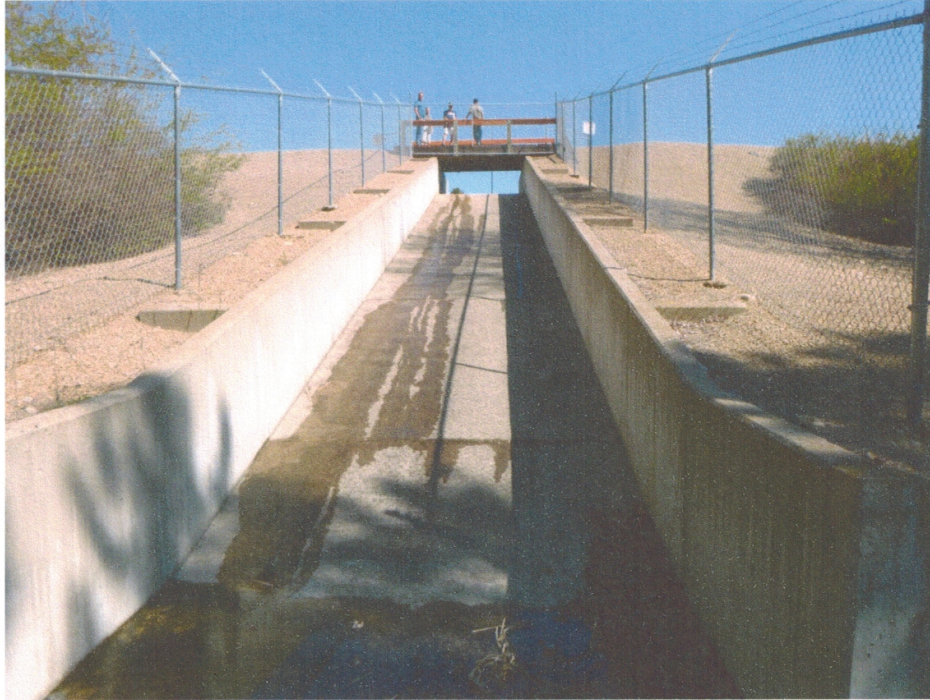
Photo 11: Emergency Spillway on South Dam, looking upstream

2019 Inspection. At the time of the inspection, water was approximately 1-2 inches lower than the spillway entrance. A visual inspection of the spillway structure at the crest and the downstream embankment did not show any signs of failure or instability (see Photos 10 and 11), aside from minor cracking. It is recommended that significant cracks be cataloged and monitored to track long-term settlement or deterioration of the concrete.

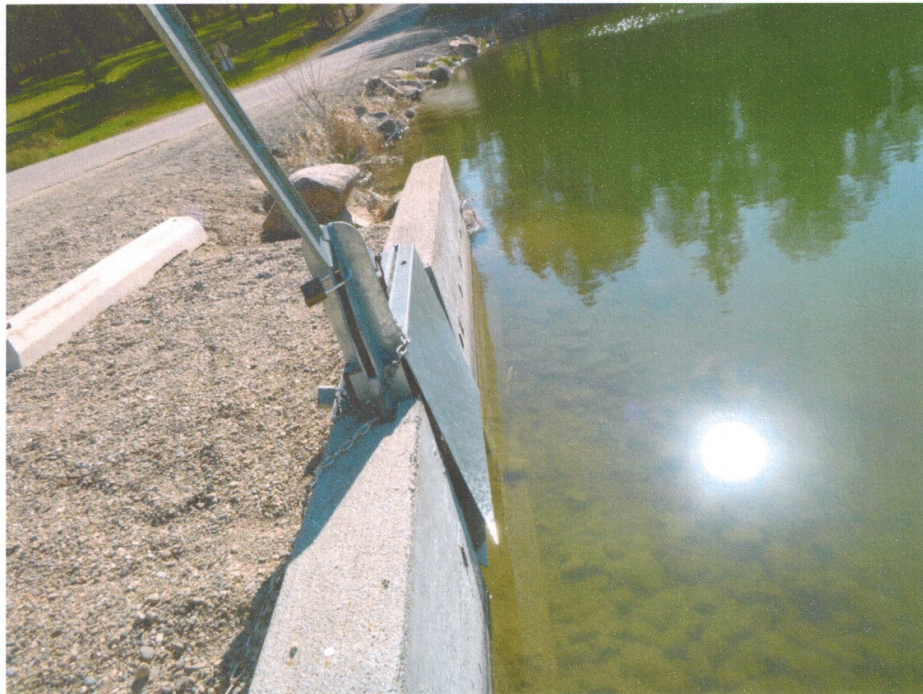
Photo 12: Auxiliary Spillway Entrance on North Dam

2019 Inspection. At the time of the inspection, the spillway pipe was flowing, and the sliding metal plate was covering the entrance, although it is not known if it was fully lowered (see Photo 12). The concrete headwall appeared to be in good condition, with no visible signs of deterioration in the concrete structure. The downstream outlet appeared to be in similarly good condition, with the corrugated metal pipe in good condition (see Photo 13). We noted a small tree in close proximity to the outlet pipe (see Photo 7) which should be removed before its root system starts to damage the outlet pipe. Similar to the Principal Spillway, we recommend that the plate be kept in an up position as much as possible.

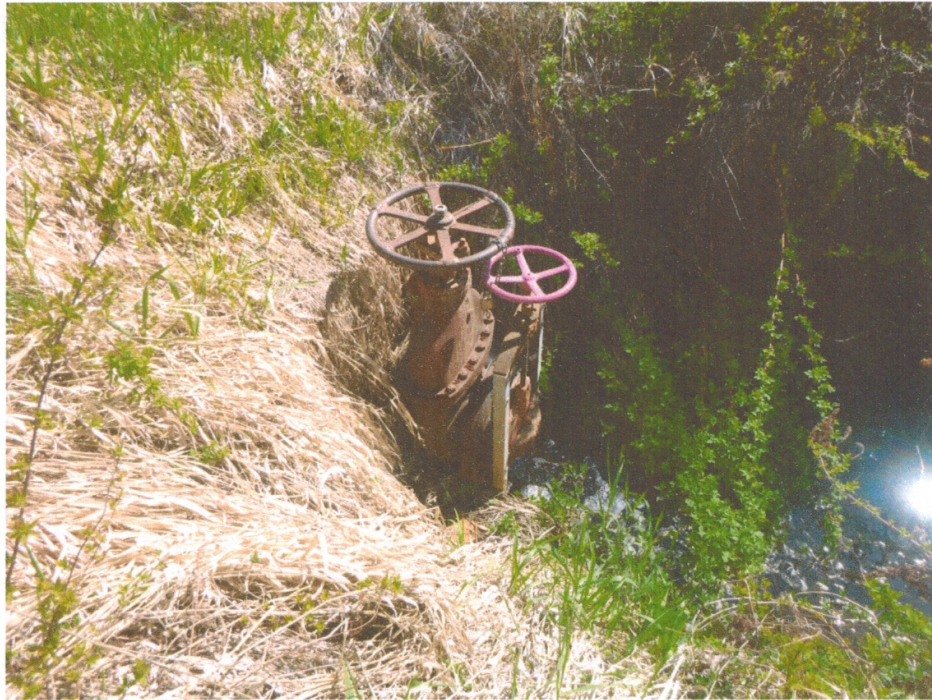
Photo 14: Low Level Outlet on South Dam

2019 Inspection. At the time of the inspection, the low-level outlet could not be inspected at the upstream end, but the downstream end was clear of vegetation (see Photo 14). The valves were not opened during the inspection, but appeared to be in good condition.

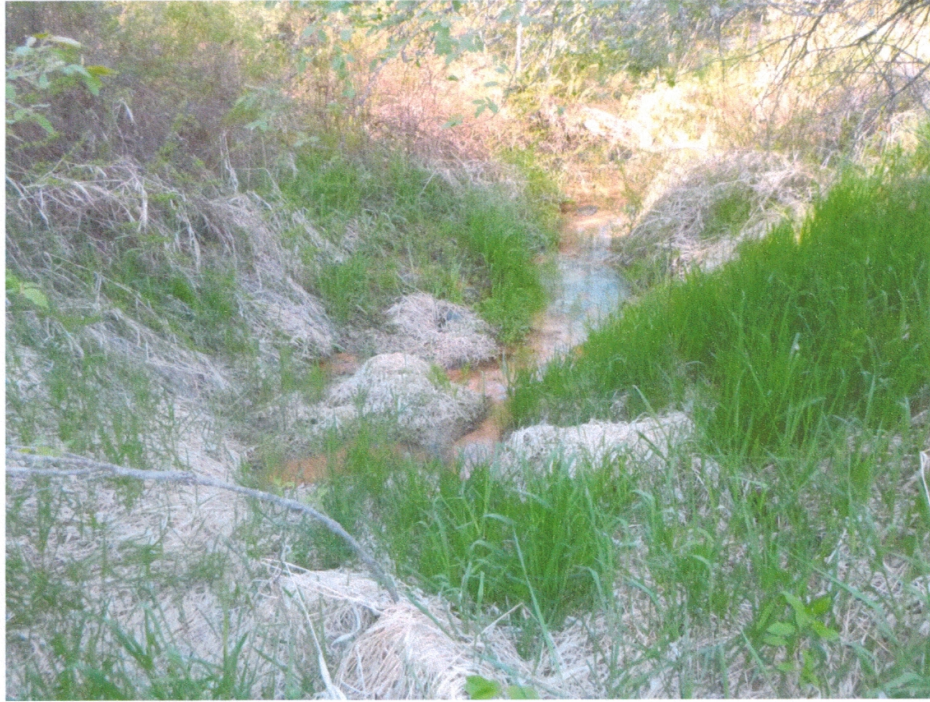
There was one area of seepage near the left abutment that produced standing water on the embankment (Photo 15). Prior inspections have mentioned the presence of seepage in the general area of the left abutment, going back as far as 1999, and the current seepage is essentially the same as noted in the 2014 inspection report. There was no indication of fine sediment transport through the embankment at the time of inspection, but it is required to monitor this area and any other developing seeps.

Photo 15: Seepage near the left abutment on South Dam

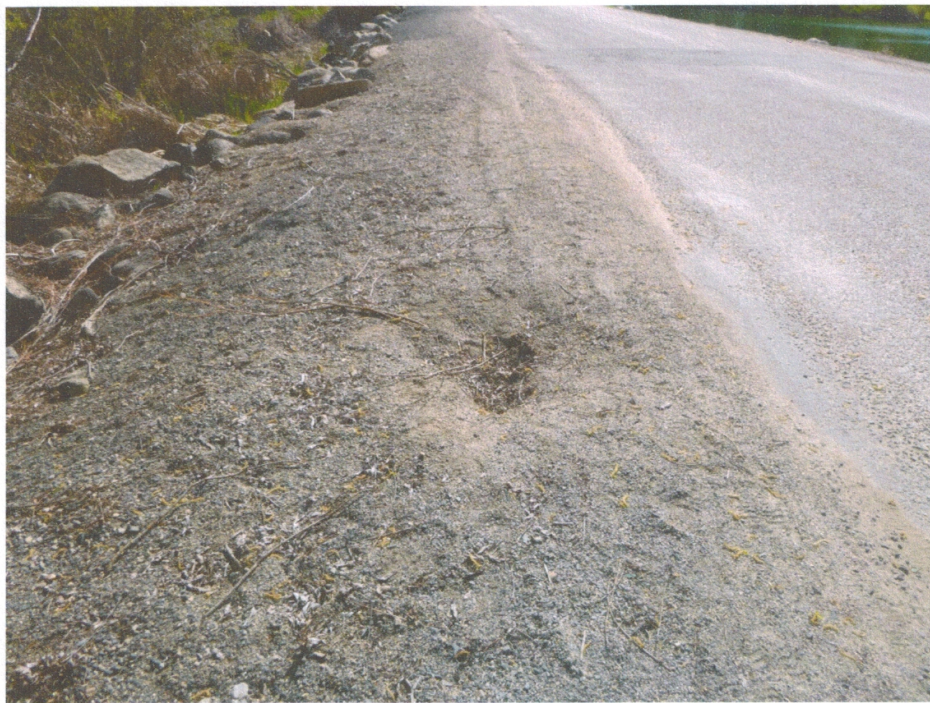
Photo 16: Slumping area near the left abutment on North Dam

4. Monitor slumping area near left abutment of North Dam. We found a small slumping area near the left abutment on the North Dam. It is required to patch this area with fill materials and monitor periodically. The DSO should be notified with any signs of slump or depression.
5. Update the O&M manual. Please provide any necessary updates for the O&M document for the facility. The manual should be completed and a copy submitted to the Dam Safety Office within 180 days of this report.
6. Update the EAP. Please provide an EAP document with current contacts and any other changes that have been applied. For more detail, please refer to the Emergency Preparedness sections above.
