Plant Restoration Planning for a Recreational Lake Ecosystem

Holly A. Fijolek¹, Mia Mastrangelo¹, Jordan Kremer¹, Owen VanDerPuy¹
¹Gonzaga University, Spokane, WA

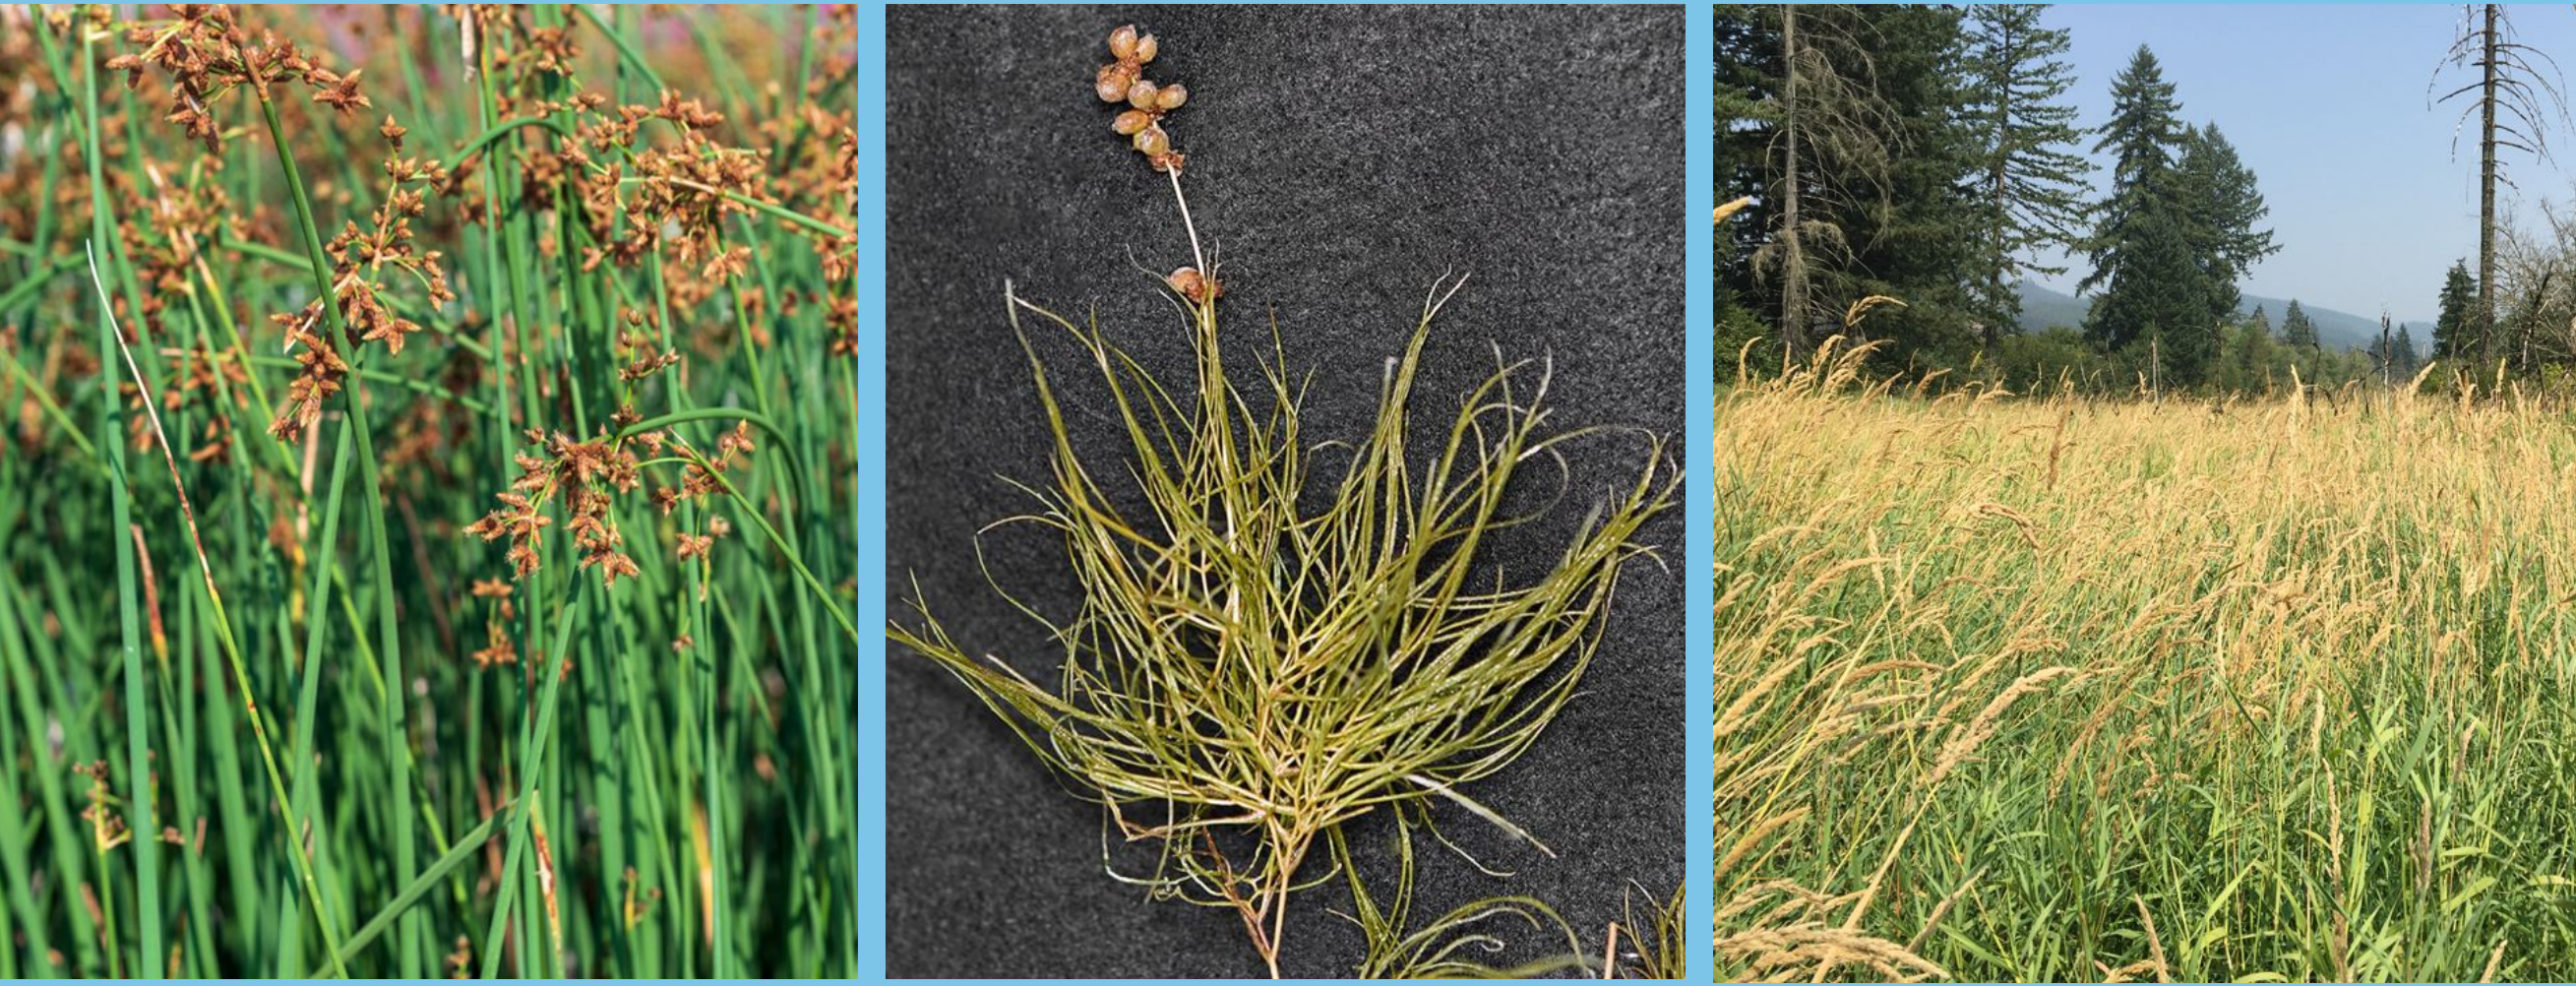
Figure 2. Hardstem Bulrush (left), Sago Pondweed (middle), and Reed Canary Grass (right) were all species observed at Reflection Lake on 10/28/24

Plant Name	Vegetation Type	Site Found
Sago Pondweed (<i>Stuckenia pectinata</i>) (Fig 2)	Submerged	Turtle Dock, Bing's Landing
Coontail (<i>Ceratophyllum demersum</i>)	Submerged	Turtle Dock
Marsh Seedbox (<i>Ludwigia palustris</i>)	Submerged	Bishop Park, Bing's Landing
Spiral Ditch Grass (<i>Ruppia cirrhosa</i>)	Submerged	Bing's Landing
Duckweed (<i>Lemna minor</i>)	Floating	Spring Stream
*Yellow Flag Iris (<i>Iris pseudacorus</i>)	Emergent	Turtle Dock
Watercress (<i>Nasturtium officinale</i>)	Emergent	Spring Stream
Rice Cutgrass (<i>Leersia oryzoides</i>)	Emergent	Bald Eagle Point
Broadleaf Cattail (<i>Typha latifolia</i> L.)	Emergent	Bald Eagle Point, Bing's Landing
Hardstem Bulrush (<i>Schoenoplectus acutus</i>) (Fig 2)	Emergent	Bald Eagle Point
*Curly Dock (<i>Rumex crispus</i>)	Terrestrial	Bald Eagle Point
*Reed Canary Grass (<i>Phalaris arundinacea</i>) (Fig 2)	Terrestrial	Bald Eagle Point, Turtle Dock

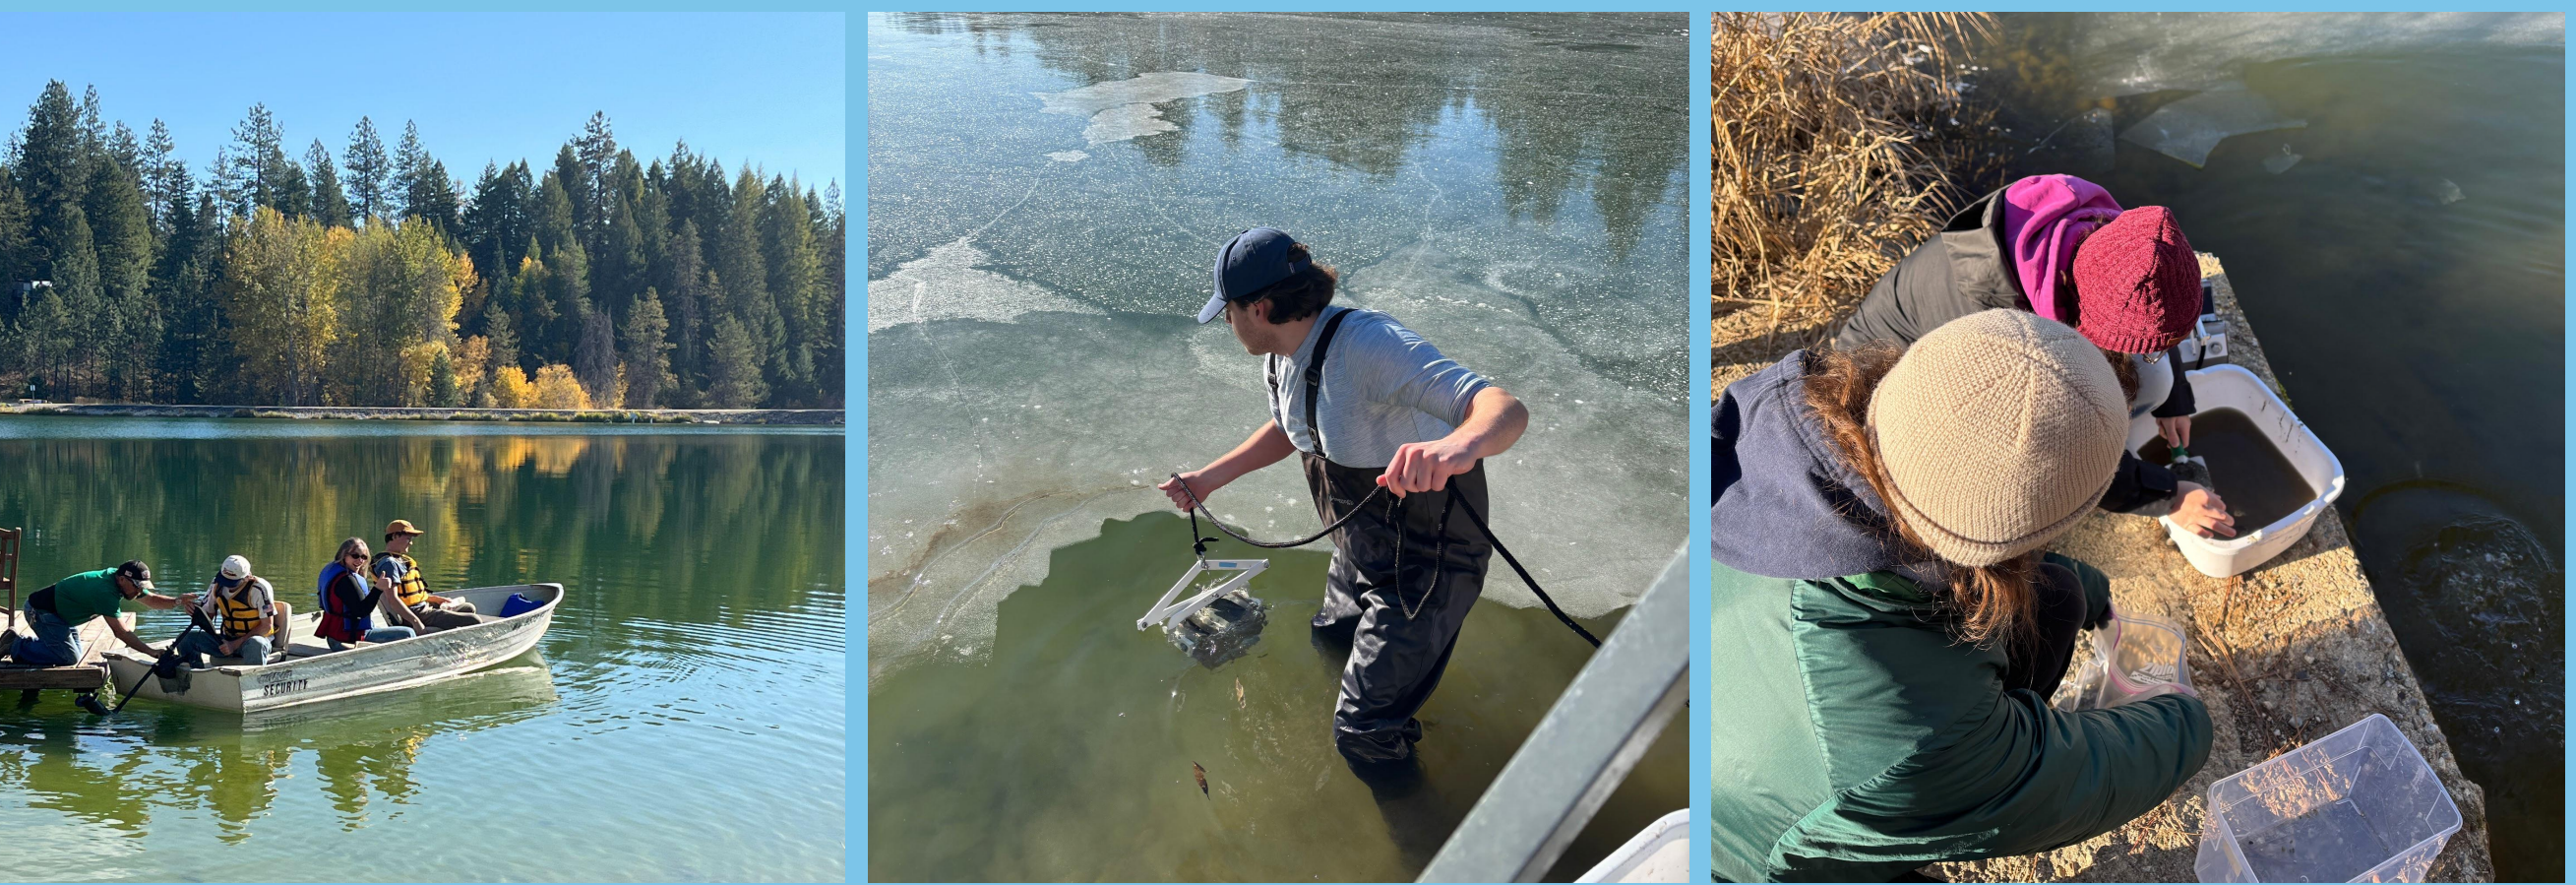
Above: Figure 4. Water and sediment sampling at Reflection Lake
Below: Figure 5. Reflection Lake on October 13th, 2024

- Vernier Go Direct probes used to measure water quality parameters at the surface, Secchi disk used for turbidity measurements
- Water samples collected at six locations around the lake (Fig. 1, 4)
 - Filtered on site through 0.45µm filters
- Water samples analyzed using ion chromatography
