2019 Periodic Inspection Report

*Reflection Lake South and North Dams
Spokane County, Washington*

November 2019

DSO File SP55-0050, 0362

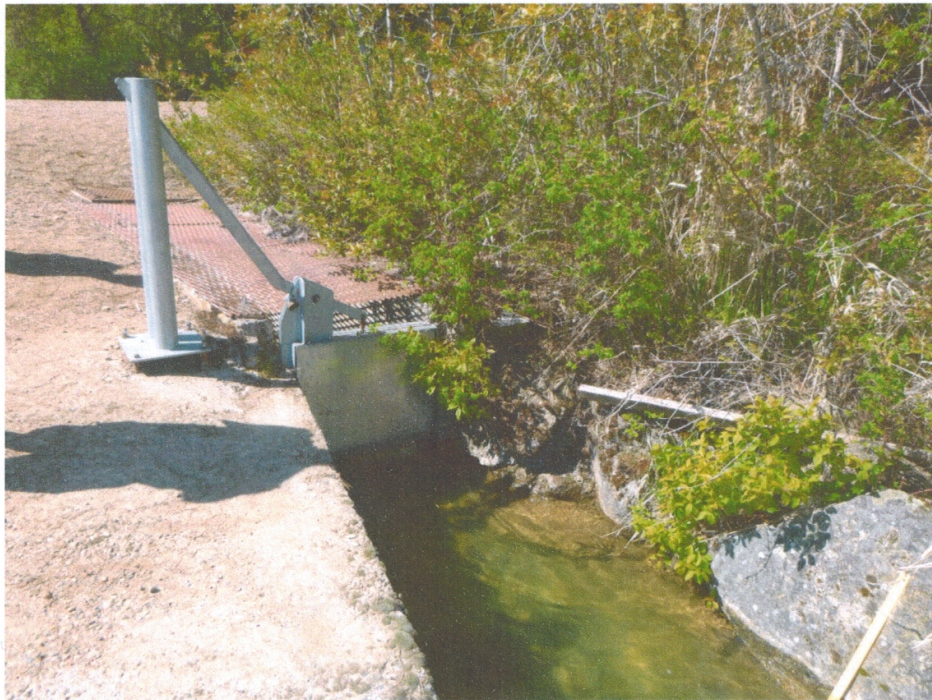
Photo 8: Principal Spillway Entrance on South Dam

2019 Inspection. At the time of the inspection, water was flowing in the outlet, approximately 1/3 full (see Photo 9). A visual inspection of the downstream chute revealed that the chute and concrete support were in good condition, with no visible damage or instability. The sliding plate at the spillway entrance appeared to be completely lowered, although water was able to pass through. It should be noted that the metal plates would significantly hinder flow through the outlet. In most cases that will not be an important issue, but should be taken into consideration for significant storm events. It is suggested that this plate be kept in an up position as much as possible.

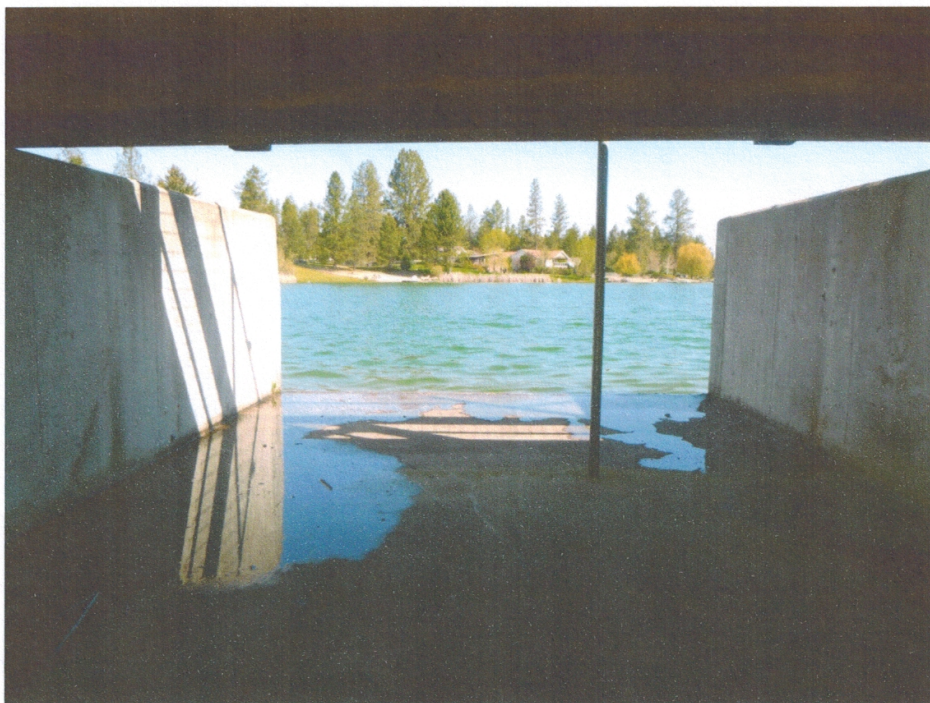
2019 Inspection. At the time of the inspection, water was approximately 1-2 inches lower than the spillway entrance. A visual inspection of the spillway structure at the crest and the downstream embankment did not show any signs of failure or instability (see Photos 10 and 11), aside from minor cracking. It is recommended that significant cracks be cataloged and monitored to track long-term settlement or deterioration of the concrete.

Photo 10: Emergency Spillway Entrance on South Dam

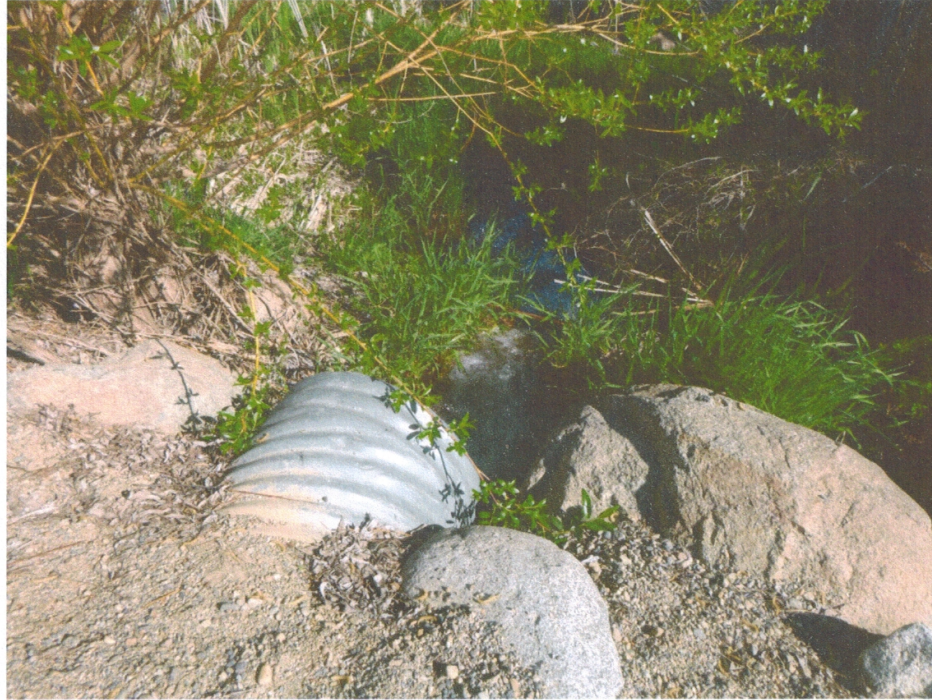
Photo 13: Auxiliary Spillway Discharge on North Dam
